CONNECTICUT RIVER BASIN  
PALMER, MASSACHUSETTS

DIAMOND INTERNATIONAL CORPORATION  
UPPER DAM  
MA 00562

**PHASE I INSPECTION REPORT  
NATIONAL DAM INSPECTION PROGRAM**

OCTOBER 1980

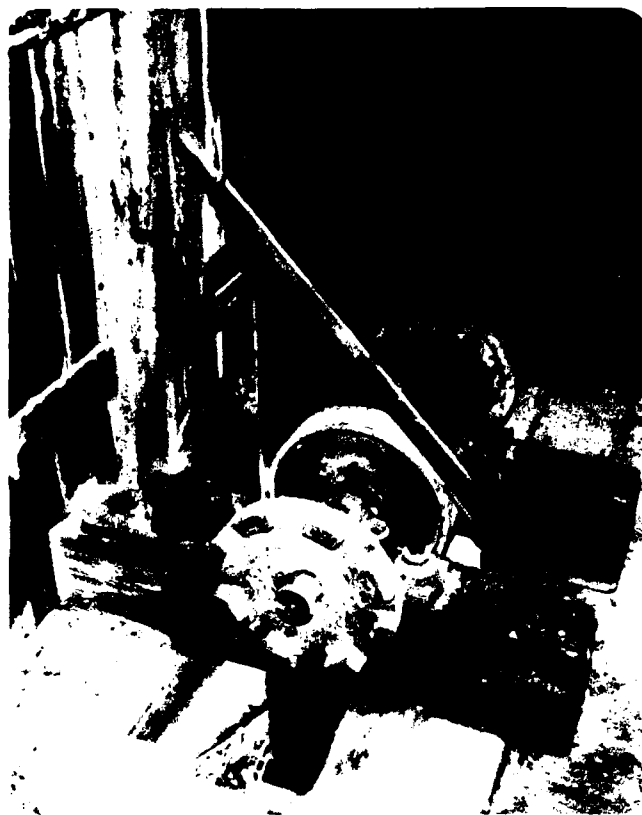
NO. 8 GATE MECHANISM INSIDE CANAL GATEHOUSE

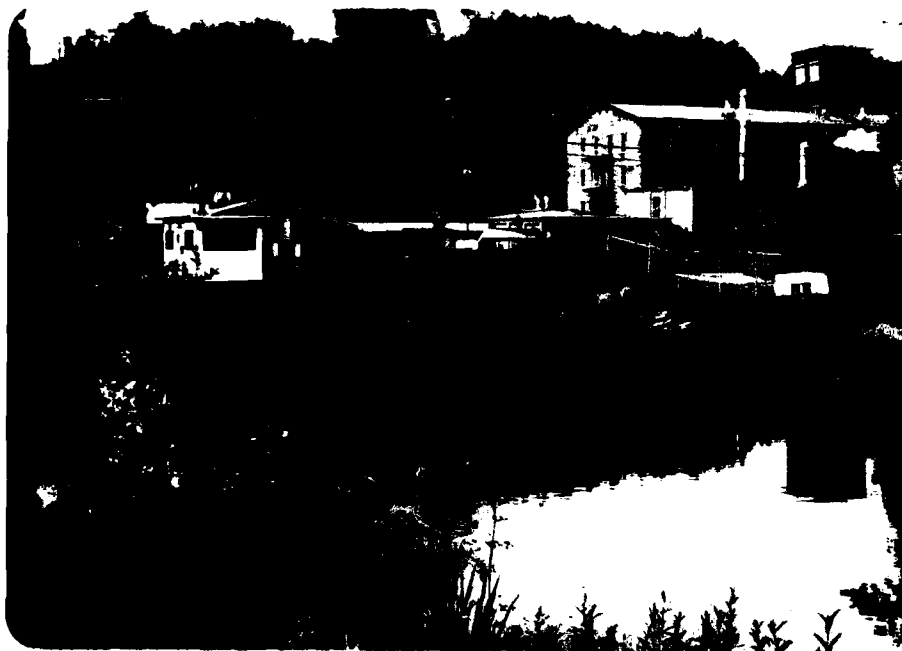
**NO. 9 CANAL LEADING TO FACTORY COMPLEX**

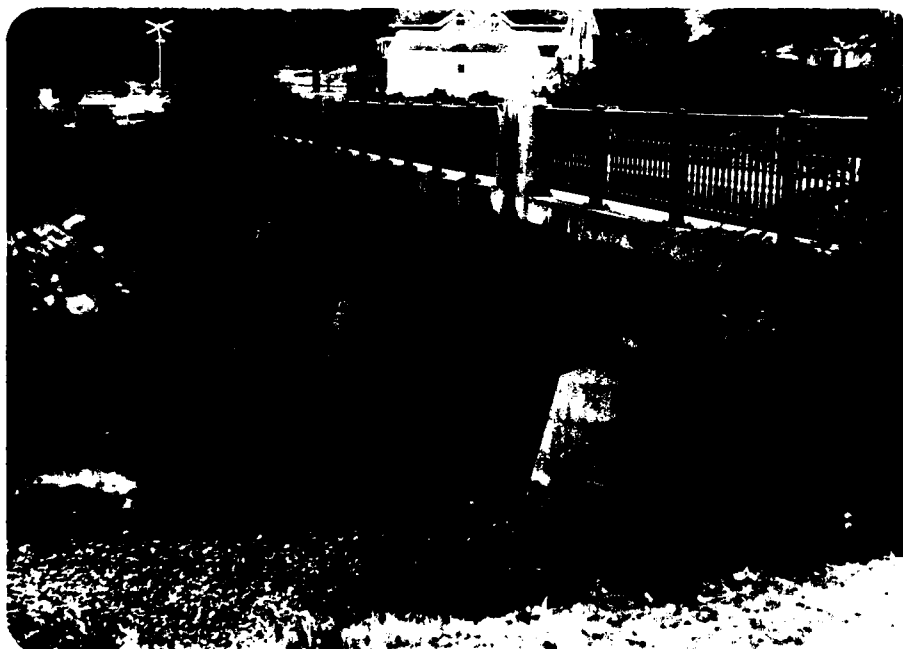
About 1,000 feet downstream of the dam, the Pleasant Street bridge spans the Ware River channel. Under normal conditions there is no restriction to flow of discharge from the spillway. Water flows under the bridge in three 12 to 14-foot high archways (see Photo No. 14).

**NO. 14 PLEASANT STREET BRIDGE OVER THE WARE  
RIVER (DOWNSTREAM OF MAIN SPILLWAY)**
